CROSSWALK ENHANCEMENT COMPARISON STUDY

May 7, 2001

Prepared by the
Department of Transportation
(408) 277-4304

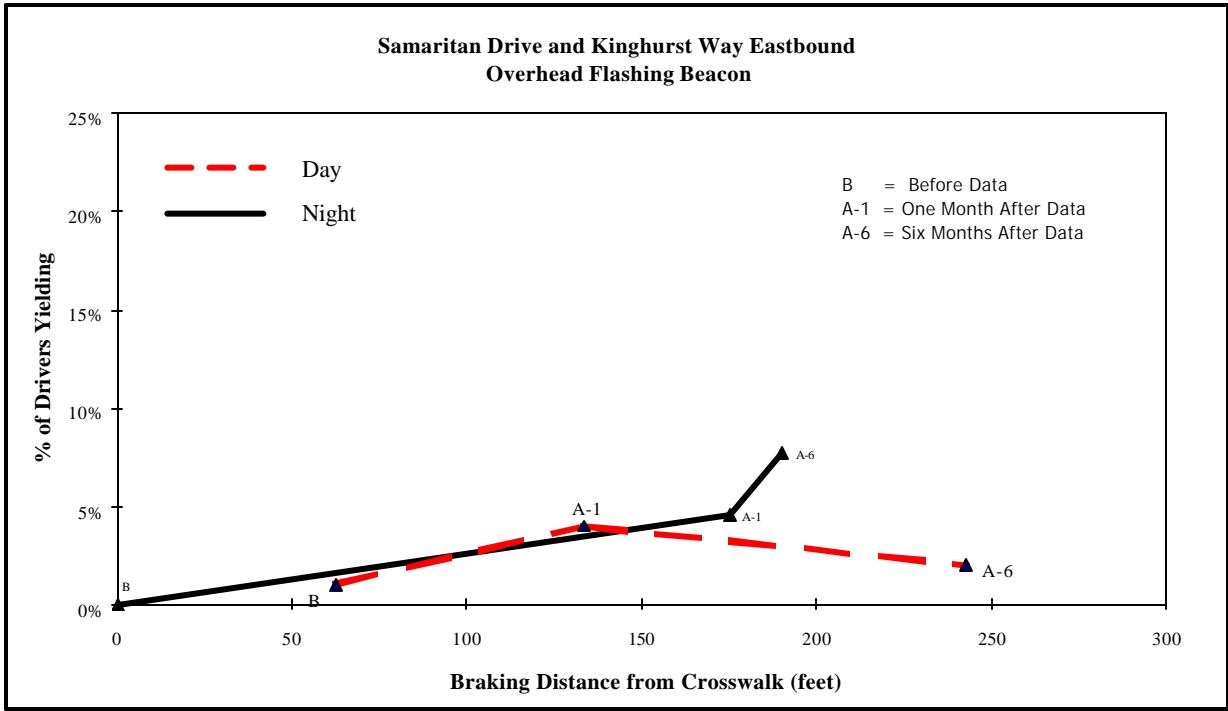
Graph 1: Samaritan Drive and Kinghurst Way eastbound

- Drivers yielding for pedestrians during the day increased from 1% in the before condition to 4% and 2% for one month and six months after installation, respectively. Braking distance during the day increased from 63 feet in the before condition to 133 feet and 243 feet for one month and six months after installation, respectively.
- Drivers yielding for pedestrians during the dark hours of the night increased from 0% in the before condition to 5% and 8% for one month and six months after installation, respectively. Braking distance during the night increased from none in the before condition to 175 feet and 190 feet for one month and six months after installation, respectively (see Graph 1).

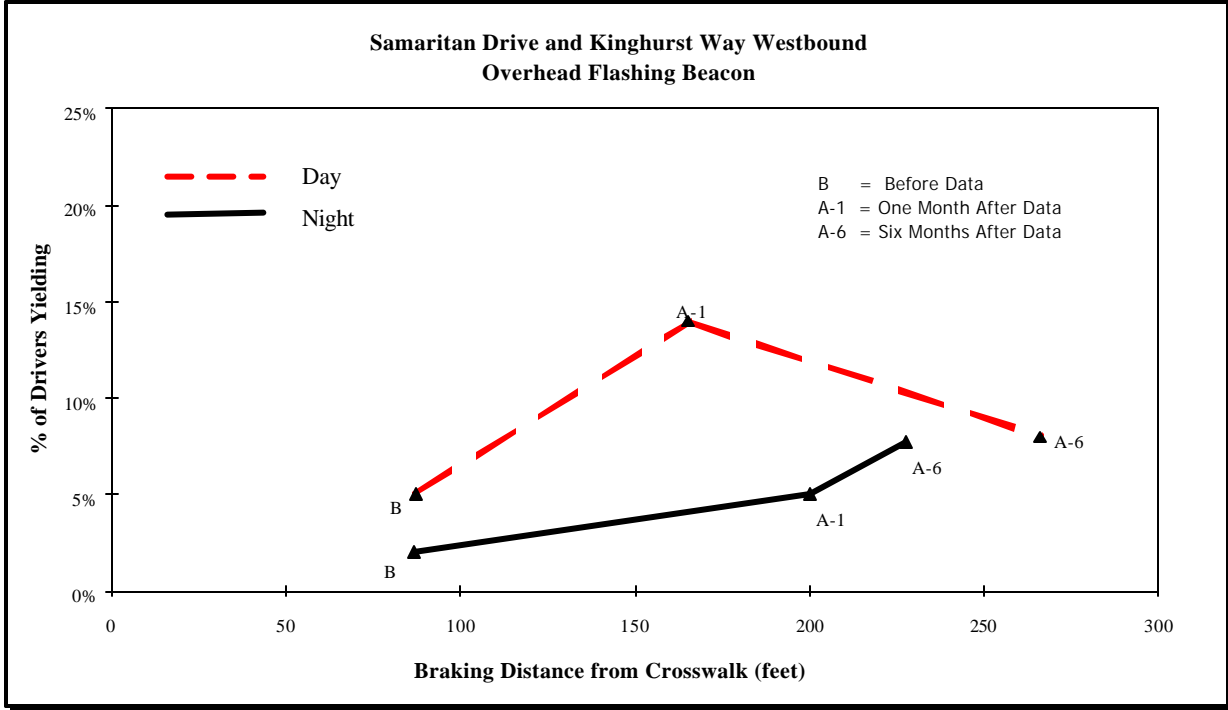
Graph 2: Samaritan Drive and Kinghurst Way westbound

- Drivers yielding for pedestrians during the day increased from 5% in the before condition to 14% and 8% for one month and six months after installation, respectively. Braking distance during the day increased from 87 feet in the before condition to 165 feet and 266 feet for one month and six months after installation, respectively.
- Drivers yielding for pedestrians during the night increased from 2% in the before condition to 5% and 8% for one month and six months after installation, respectively. Braking distance during the day increased from 87 feet in the before condition to 200 feet and 228 feet for one month and six months after installation, respectively (see Graph 2).

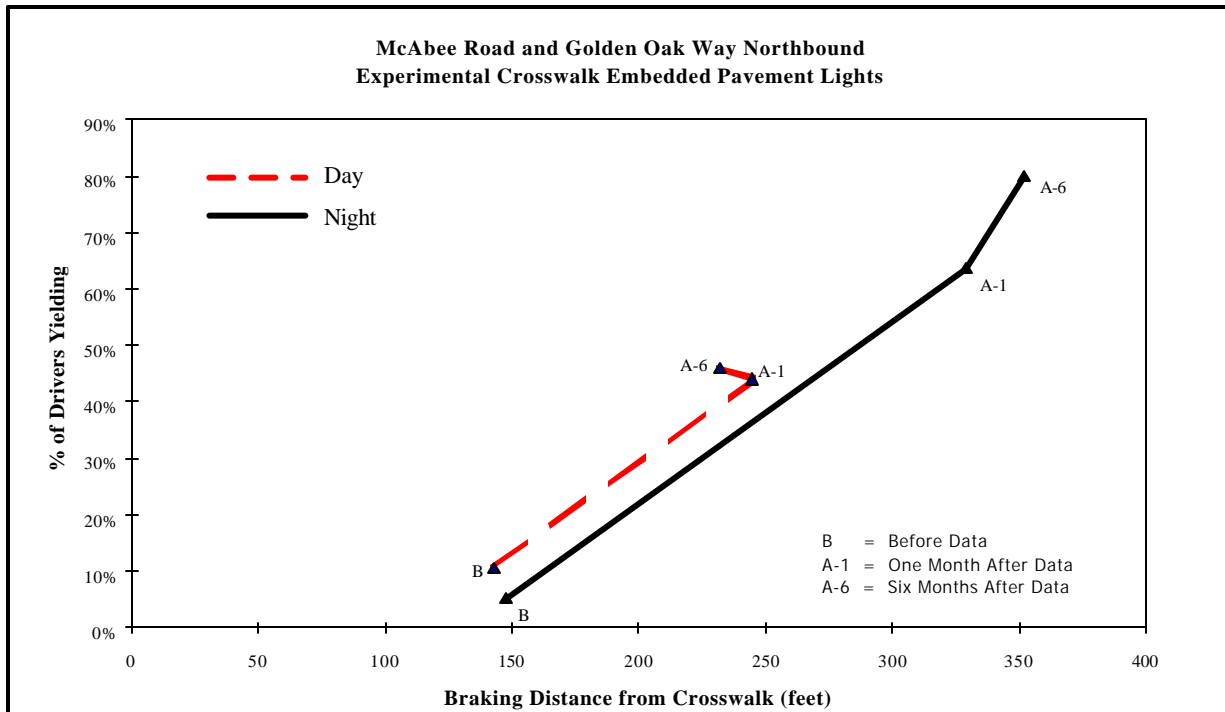
Graph 3: McAbee Road and Golden Oak Way northbound

- Drivers yielding for pedestrians during the day increased from 10% in the before condition to 44% and 46% for one month and six months after installation, respectively. Braking distance during the day increased from 143 feet in the before condition to 245 feet and 232 feet for one month and six months after installation, respectively.
- Drivers yielding for pedestrians during the night increased from 5% in the before condition to 64% and 80% for one month and six months after installation, respectively. Braking distance during the night increased from 148 feet in the before condition to 329 feet and 352 feet for one month and six months after installation, respectively (see Graph 3).
