Evaluation of In-Pavement Lighted Crosswalks

**Report to Bangor Area Comprehensive Transportation System (BACTS)
March 4, 2005**

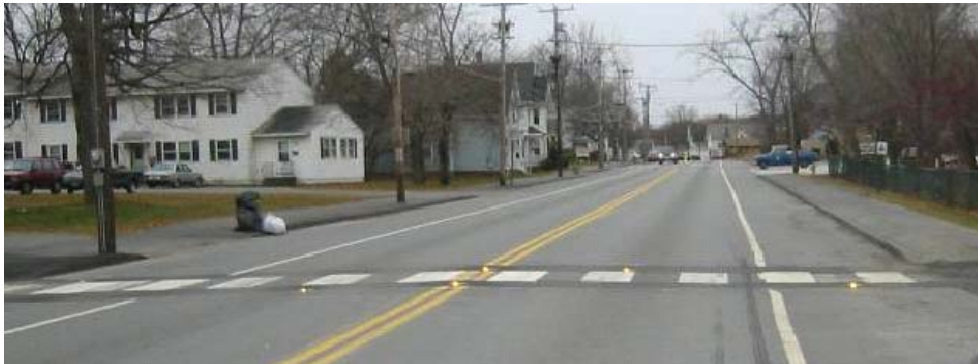
Figure 1 South Main Street, Brewer

The fall 2004 Transportation Safety class was asked to evaluate the lighted crosswalks in Old Town and Brewer. The crosswalks, shown in Figures 1-3, are located across Center Street at Elm Street in Old Town and across South Main Street, adjacent to Eastern Park, in Brewer. A third installation is planned for College Avenue in Orono. That installation will be using SmartStud by Econolite. The in-pavement lighting systems for the studied crosswalks were placed there in the early fall of 2004 to improve driver yield behavior. One reason drivers do not yield to pedestrians in crosswalks may be that the drivers have not seen the pedestrians. Flashing in-pavement lights should dramatically increase the likelihood that drivers will look for pedestrians, which in turn should improve their chances of seeing a pedestrian. The systems are said to increase driver yield behavior significantly—or by about 45% according to Sandi Duchesne with the Bangor Area Comprehensive Transportation Study (BACTS) in the press release *Innovative Technology Reminds Motorists to Yield*. To study whether that is the case or not is one aspect of this study. The installations were highlighted in the November 12, 2004 *Bangor Daily News* article “Old Town installs high-tech crosswalk” By Abigail Curtis, of the News Staff.

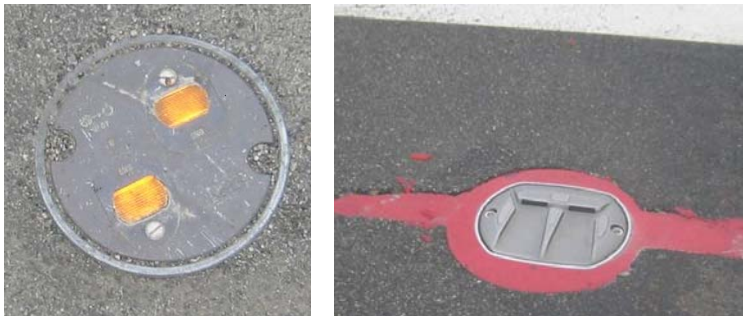
Figure 2 Brewer (by Flightlight, see <http://www.flightlight.com/index.shtml>) and Old Town lights (by LaneLight, see <http://www.itemltd.com/products/lanelight/index.html>)

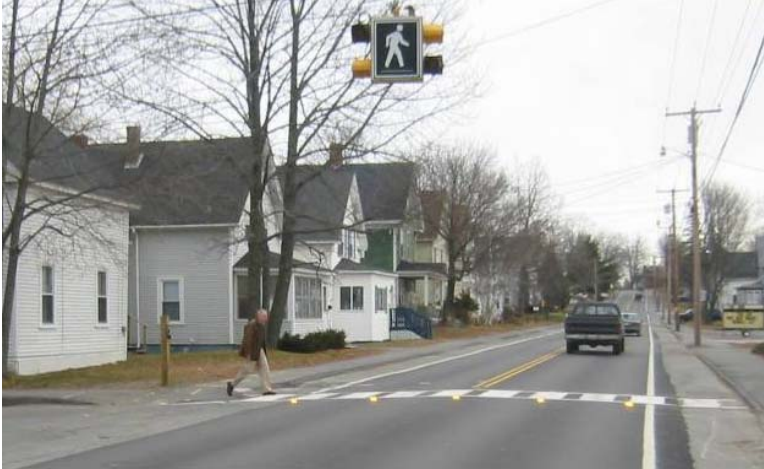
Figure 3 Center Street, Old Town—which also has a time-actuated, overhead school-crossing light

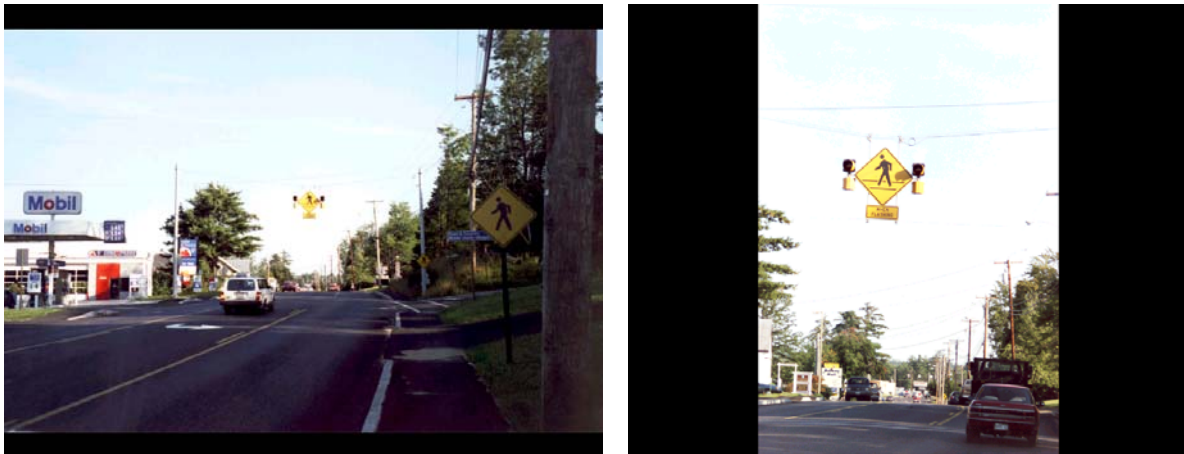
Figure 4 Crosswalk in Norway, Maine

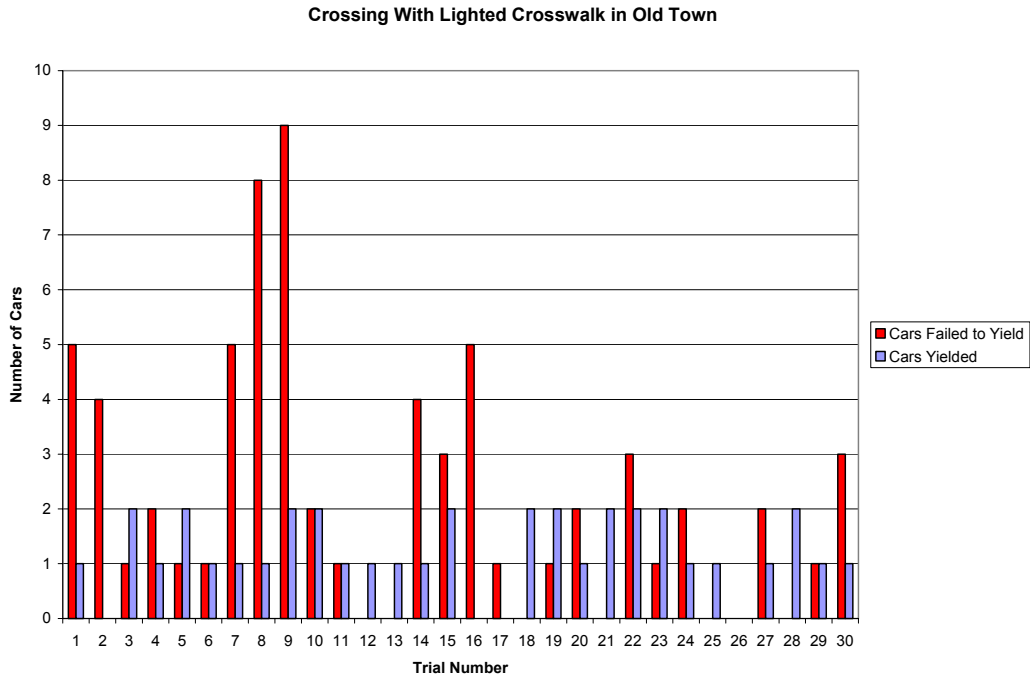
Figure 5 Example of yield observations at light-activated crosswalk in Old Town

- When the in-ground lighting was activated, 29 drivers (21%) out of 135 (approaching in such a way that they could have stopped) yielded, see Figure 5.
- When the in-pavement lighting system was not activated, 22 out of 194 (11%) yielded to the pedestrian in the crosswalk, see Figure 6.

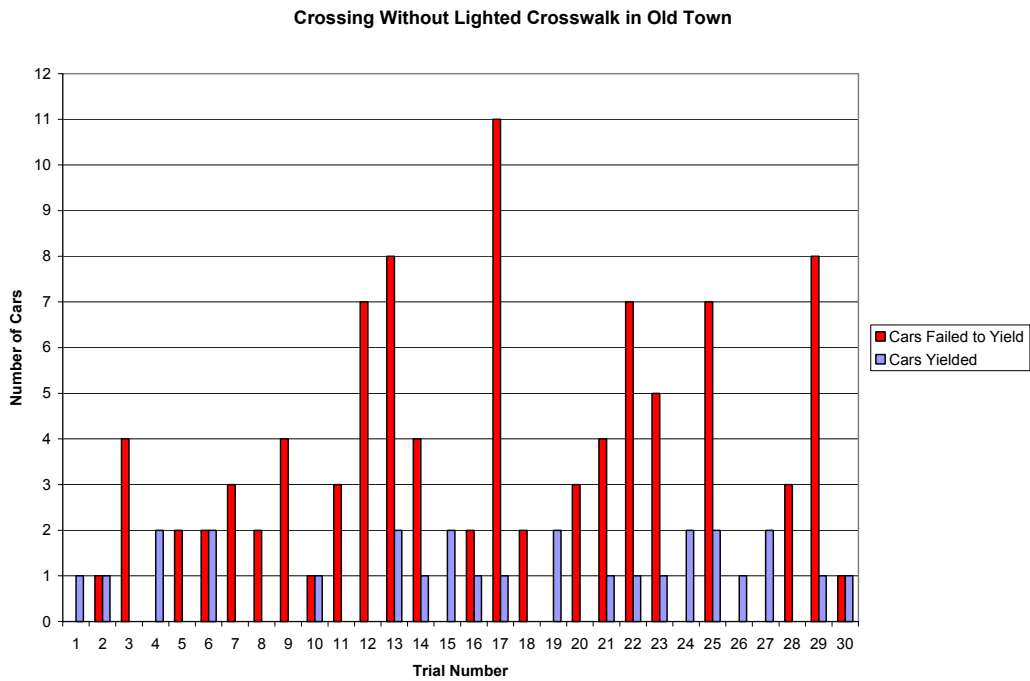
Figure 6 Example of yield observations at not activated crosswalk in Old Town

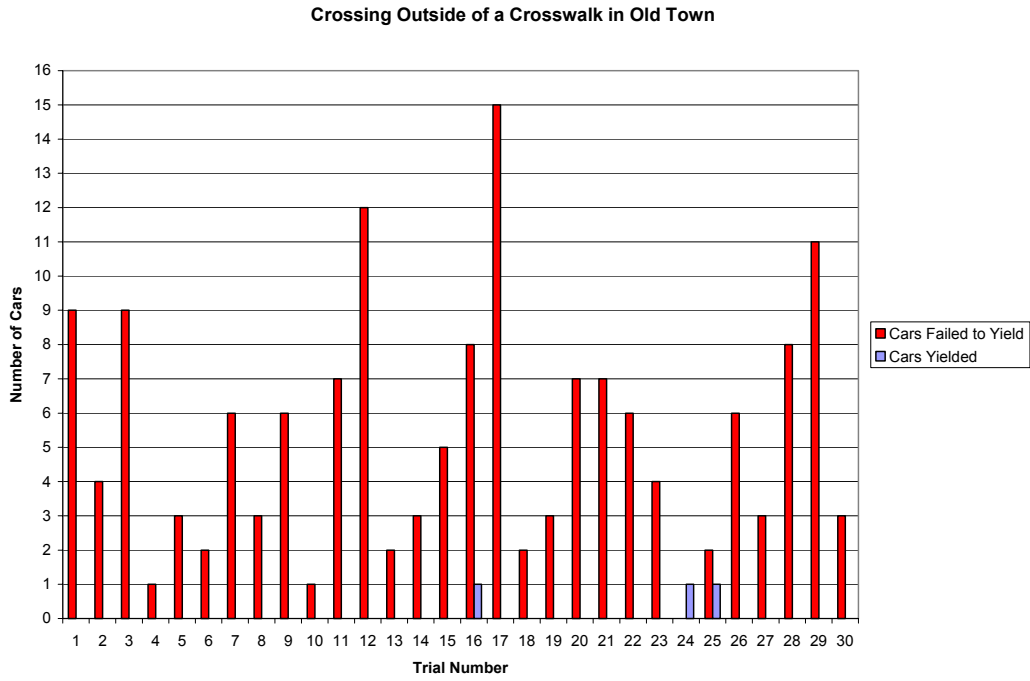
Figure 7 Example of yield observations away from the crosswalk in Old Town

- When pedestrians attempted to cross approximately 200 yards outside the crosswalk (at a straight and level section of the road) only four out of 201 drivers (2%) yielded. A part of these observations are illustrated in Figure 7.

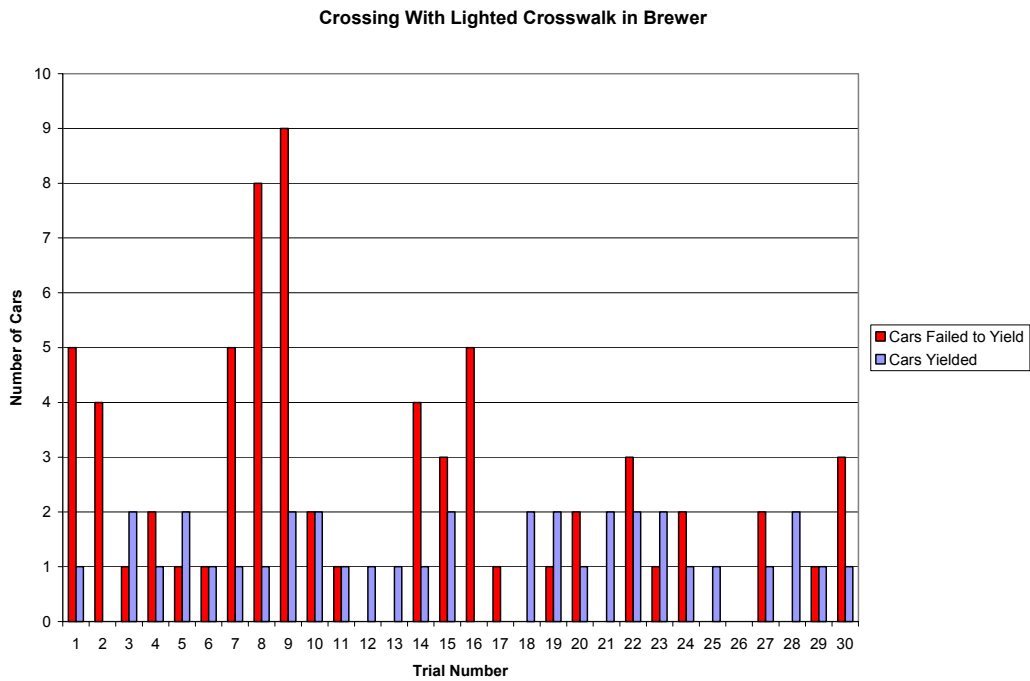
Figure 8 Example of yield observations at light-activated crosswalk in Brewer

- When the in-ground lighting was activated, 37 drivers (36%) out of 104 (approaching in such a way that they could have stopped) yielded, see Figure 8.
- When the in-pavement lighting system was not activated, 28 out of 122 (23%) yielded to the pedestrian in the crosswalk, see Figure 9.
- When pedestrians attempted to cross approximately 200 yards outside the crosswalk (at a straight and level section of the road) three out of 161 drivers (2%) yielded, see Figure 10.

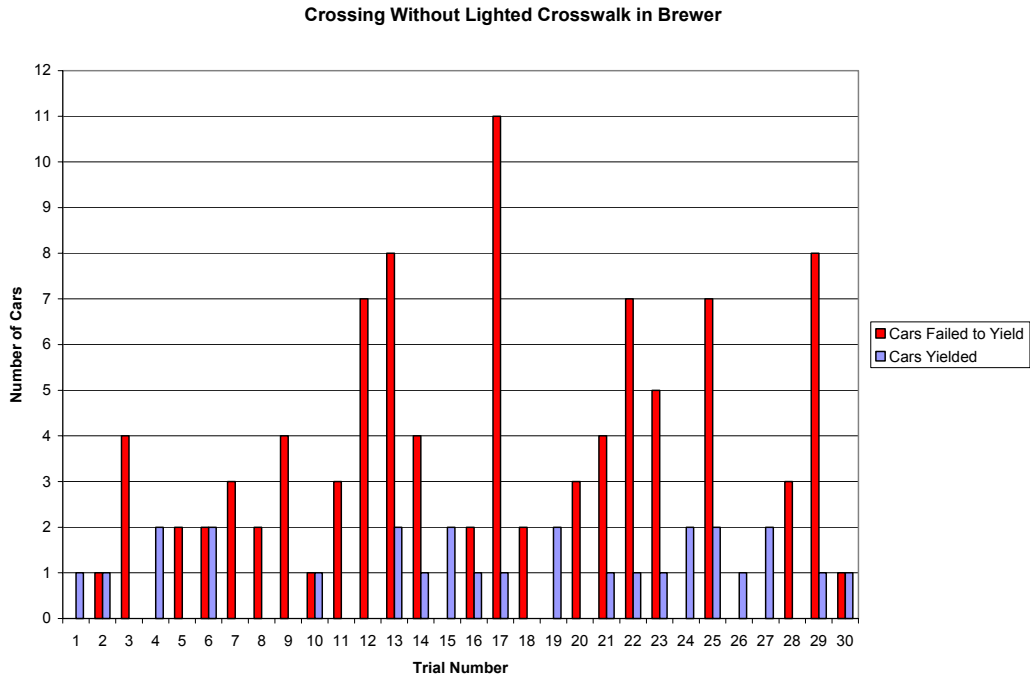
Figure 9 Example of yield observations at not activated crosswalk in Brewer

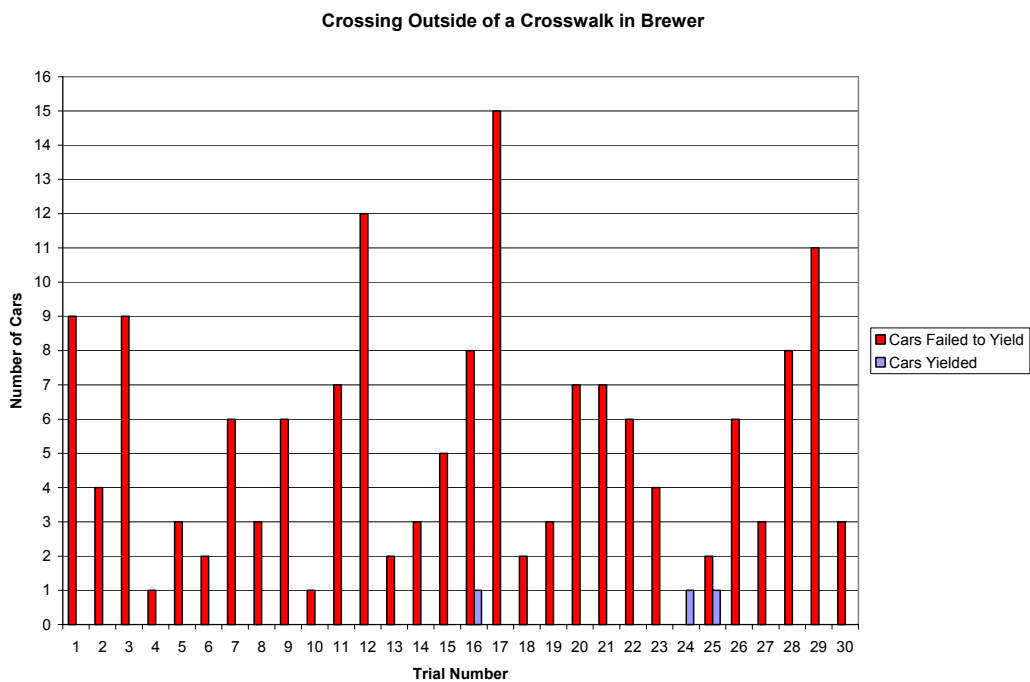
Figure 10 Example of yield observations away from crosswalk in Brewer
